LET'S TALK ABOUT MOTORS

SHATTERING SOME OLD WIVES TALES - OR THE SAME OLD STUFF JUST A SHINY NEW SHOVEL

HOW SLOW CAN YOU OPERATE A DIRECT DRIVE FAN ?

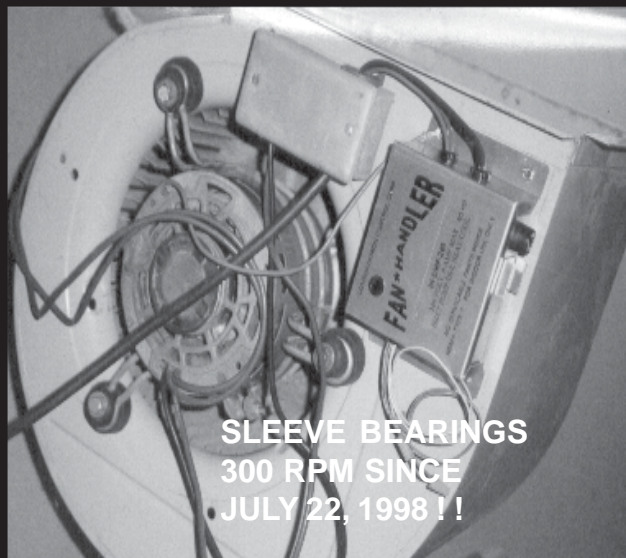
SLEEVE BEARINGS
300 RPM SINCE
JULY 22, 1998 !!

The picture in the upper left is of our bench-demo to prove that a direct drive fan motor with sleeve bearings can be run at very low speeds for extended times. We often hear the comment: "I thought you couldn't run a motor less than 500 RPM or the bearings would burn out." To prove you can, we have taken a 1050 RPM sleeve bearing motor out of an old Lennox furnace that had been operating for more than ten years and we installed a FanHandler on it and set the speed to **300 RPM**. We didn't do anything to the motor other than oil it when the demonstration started on 7-22-98. We discontinued this demonstration about May 2004, when we moved to our new shop. It was still going strong. It ran all that time at **300 RPM and without oiling the bearings.**

Sleeve bearing catalogs shows run times for every RPM and pressure load. The slower the shaft turns in a bearing, the longer it will last. The lighter the load the longer the bearing will last. Also, when a fan motor shuts off, the oil wicks back into the bearing so the next start is on a dryer bearing surface.
